Condition Report and Treatment Proposal

Title: George Washington
Location: W. Wisconsin Ave at N 9 th St. (Median) Milwaukee, WI
Owner : City of Milwaukee
Artist: Richard Henry Park
Material: Bronze on Granite base
Dated: 1885
Examined: 08-03

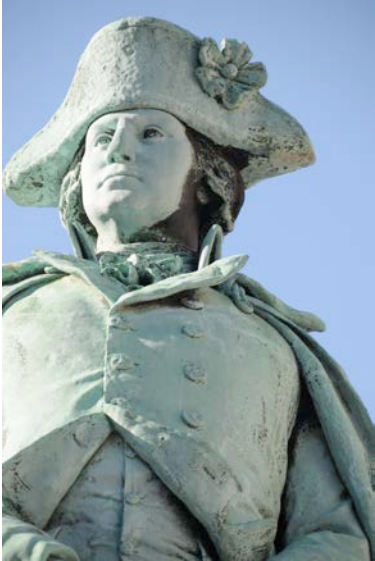
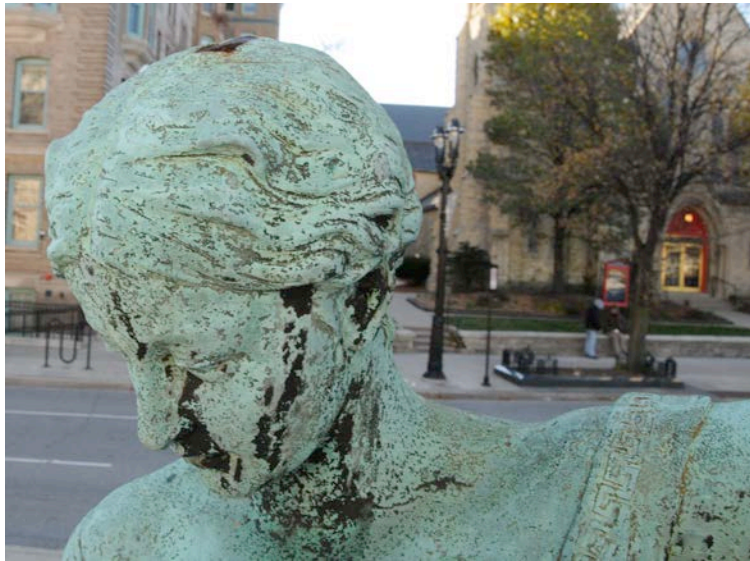
The sculpture has been exposed to an outdoor environment for a number of years. The entire surface is covered with dirt, dust, and corrosion which disfigure the intended design of the monument.

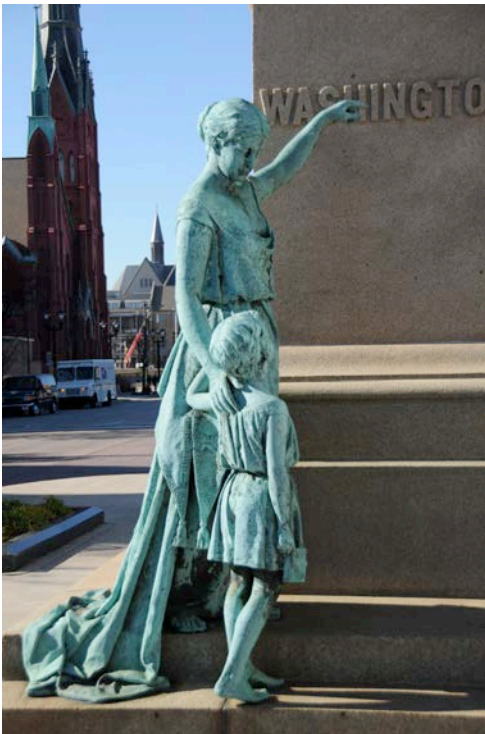
The entire bronze is covered with corrosion products. Disfiguring streaking is scattered over the entire surface of the upper figure of Washington, and the lower figure of a woman with a child.

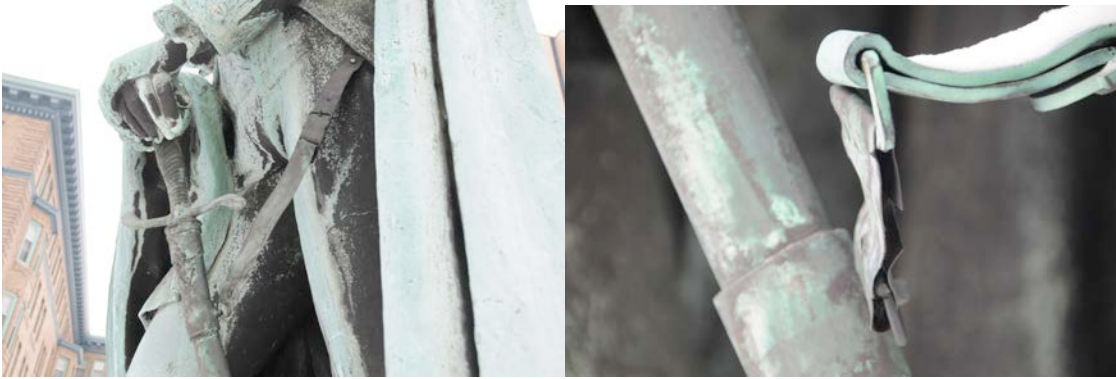
The sword is attached to the body of the sculpture with straps that are made of sheet metal. Please note the difference in thickness of metal in the above picture on the right. The straps are replacements not original to the piece. The straps connecting the sword to the sculpture are also misaligned.

8. Remove un-original straps from the sword and create new bronze straps and install them (based on historical pictures and research). It is important to also determine if the sword is original or not.
9. Create new bronze spurs and install them.

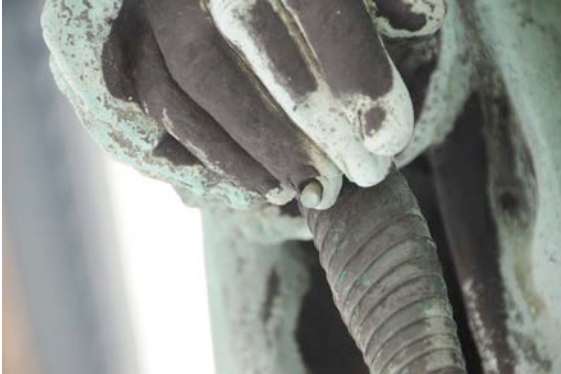
The sword is attached to the hand with a screw that is placed in a hole in the fingernail of the middle finger.

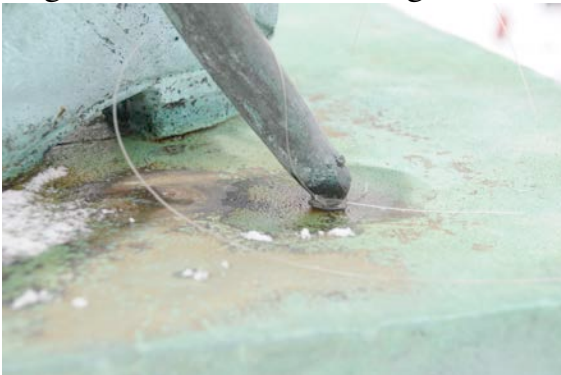
The bottom of the sword is attached to approximately 5/8" in diameter screw that is threaded into the base. There is another screw (approximately 10/24") that connects the sword to the larger screw / threaded rod. The strange way of attaching the sword to the sculpture and the presence of unoriginal straps might indicate that the sword is also not original. Research is needed in order to determine if the sword is original. Analysis of the alloys would be helpful.

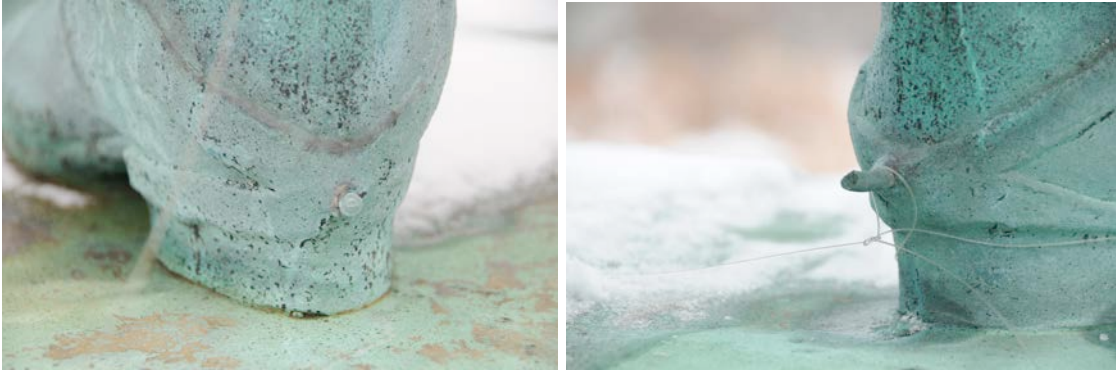
Both spurs are missing. It appears that they were replaced some time in the past because there are residues of rods that were inserted in place of larger original spurs.

9. Create new bronze spurs and install them.

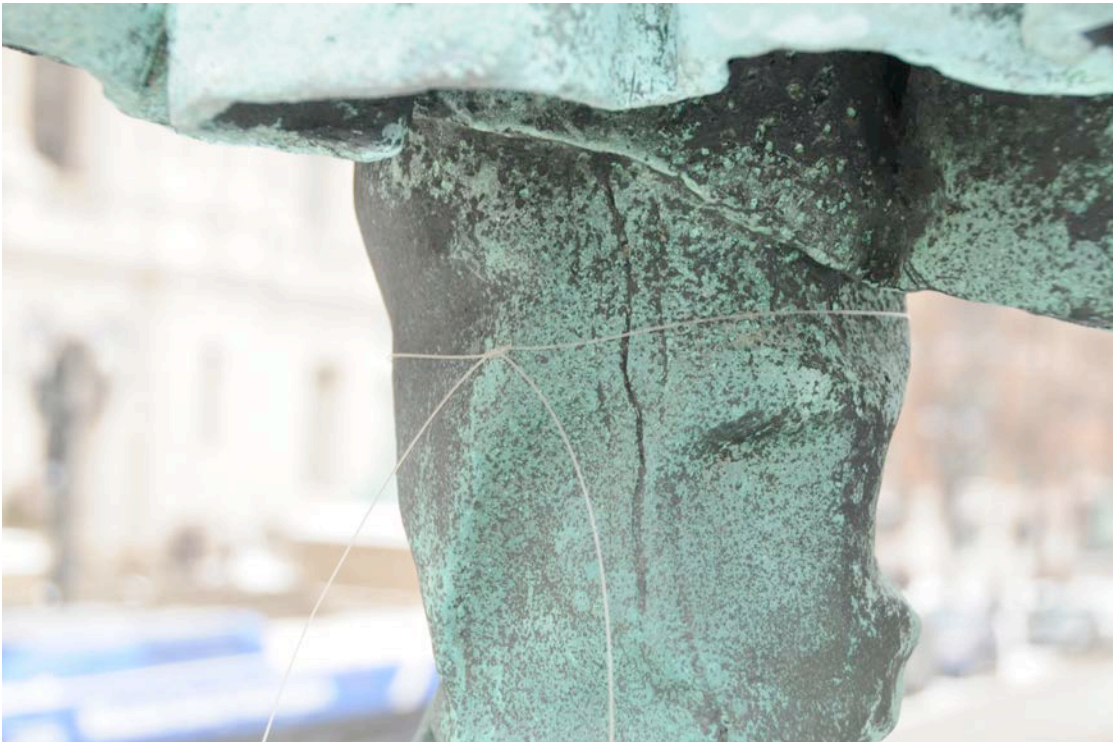
Close-up of the back surface of the proper left leg. Please note approximately 10" long vertical crack. There is a filament found tied and tangled to various parts of the sculpture.

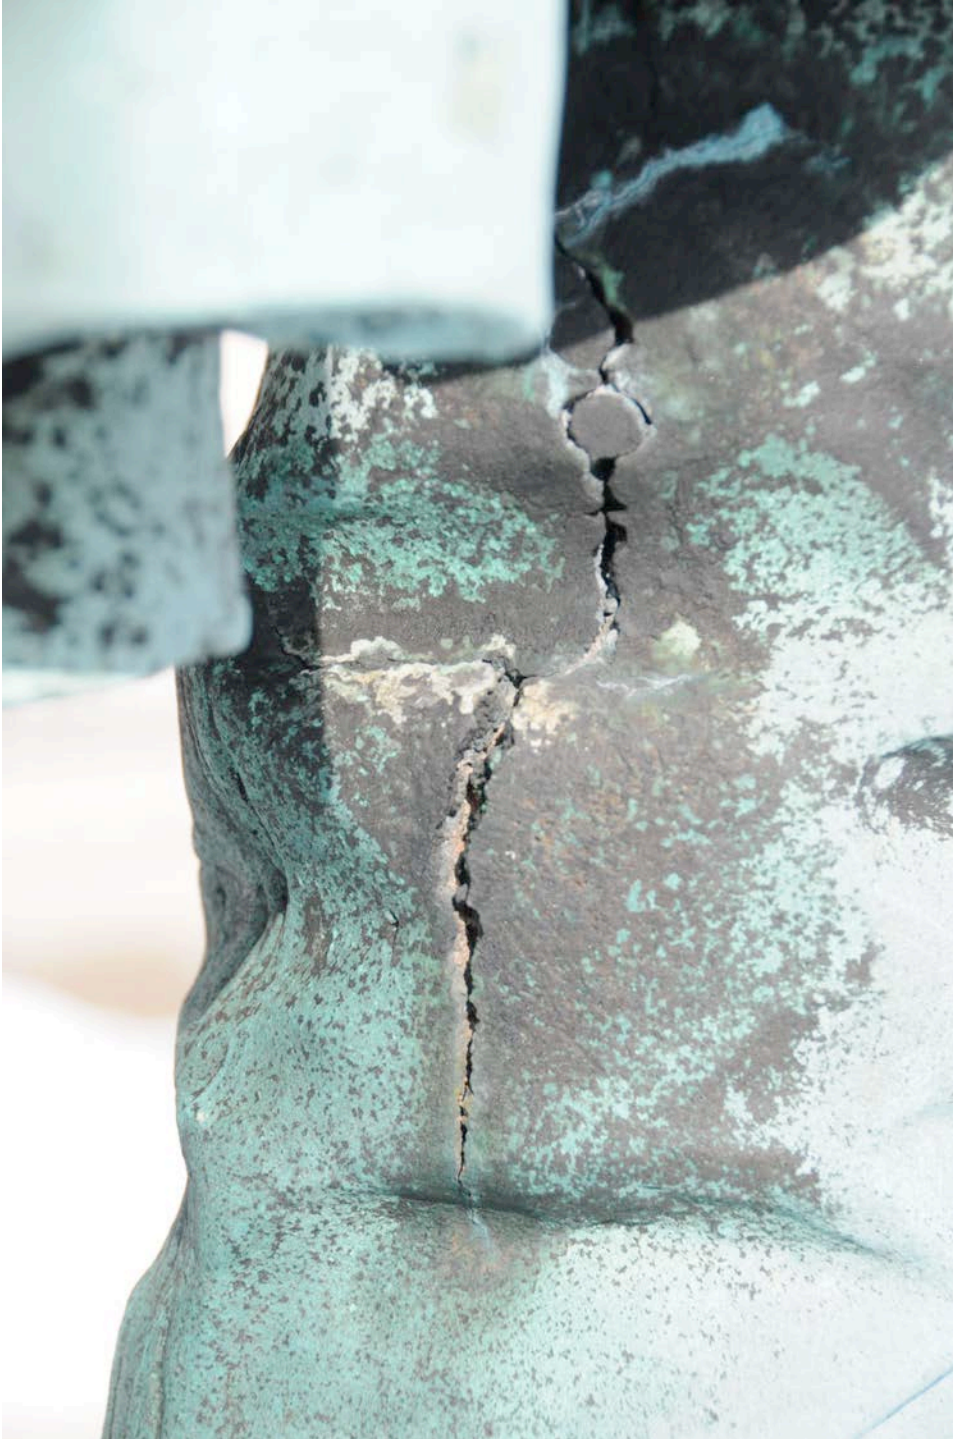
This a close-up of the back surface of the proper right leg of the figure. Please note a foot long and ¼” wide crack that was previously repaired with round inserts.

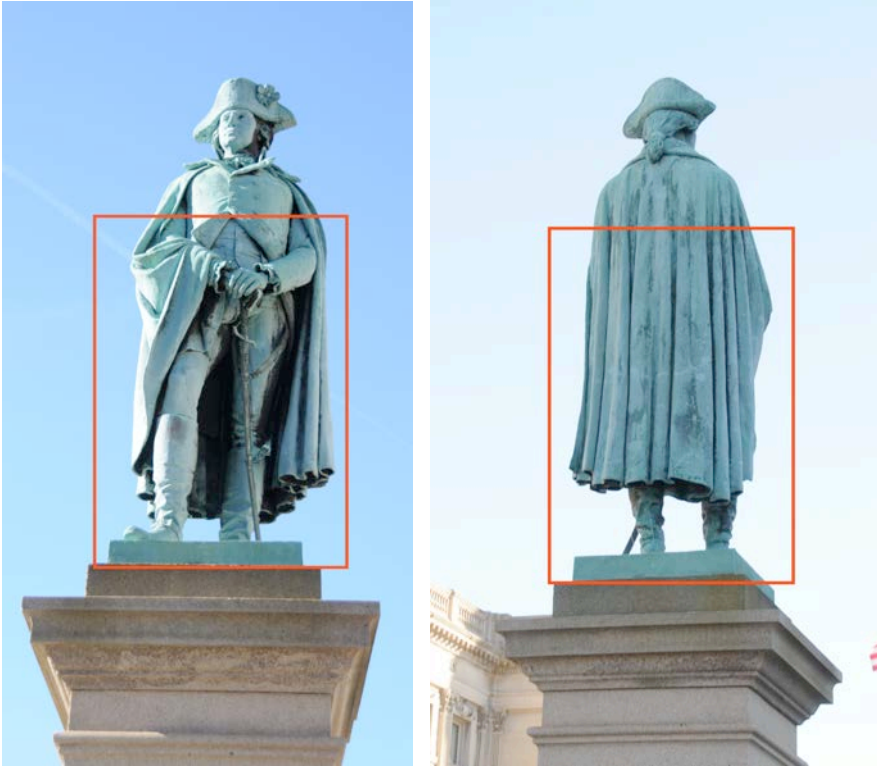
The interior of the sculpture appears to be filled in with what may be concrete or not removed casting investment. The red rectangles in both images show how high the sculpture is be filled in. This determination was made by tapping on the surface of the sculpture. Lower sections makes dull sound and the upper typical sound for a hollow bronze (bell like).

1. Remove the sculpture of the G. Washington from the pedestal and transport for treatment to CSOS.
2. Remove the concrete from the inside of the sculpture.
3. Drill weep holes and flush-out interior of the sculpture to remove any remaining core material / concrete.
4. Weld cracks in the legs and holes at the top of the figure.
5. Remove corrosion products using laser ablation process.
6. Patinate the bronze according to the owners color specifications.
Research of the original finish is needed or direction on color selection from the owner.
7. Coat the figure of Washington with Inctalac or microcrystalline wax.

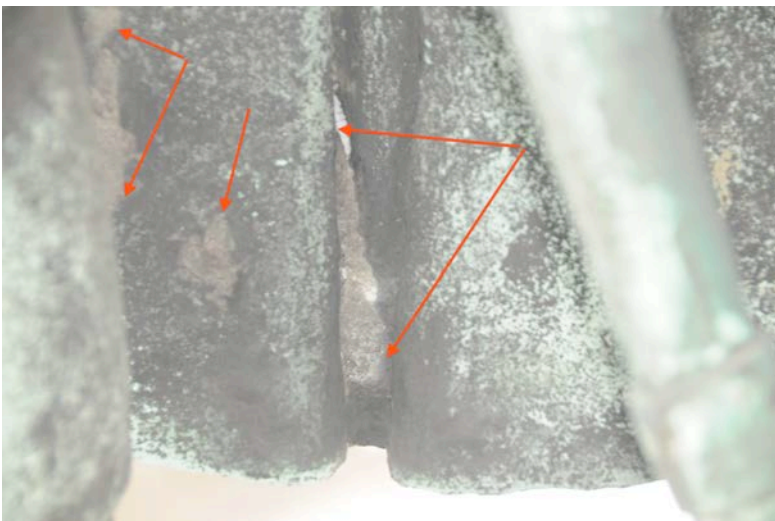
Concrete-like deposits accumulation on the external surface of the undercoat. The concrete can come out only through cracks therefore it is safe to assume that there are cracks in the bronze where the concrete deposits are found.

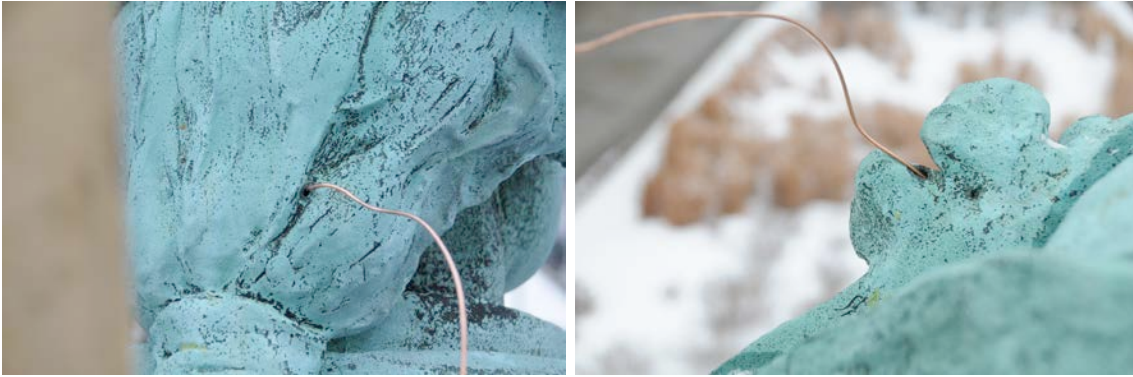
The upper section of the sculpture has approximately 10 holes that allow for water penetration to the inside. Wire is used to point out holes in the above images. The combination of water penetrating to the inside of the sculpture and concrete filling in the interior resulted in cracks in the legs of the figure of Washington.

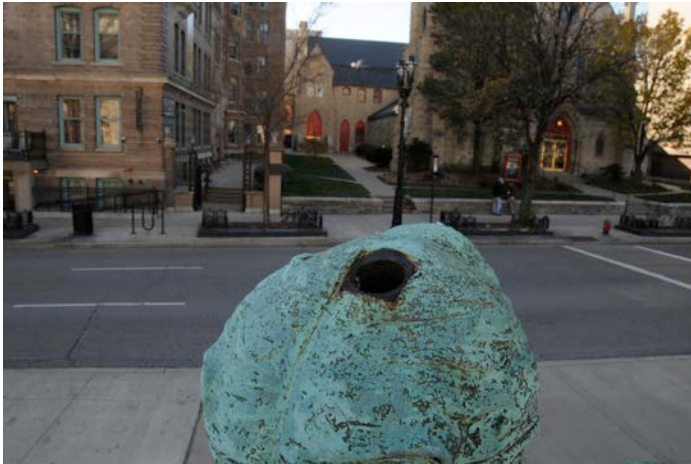
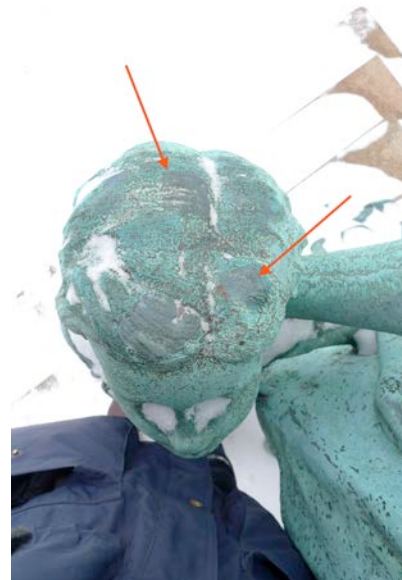
The figure of a woman and a child are filled with concrete (or not removed casting investment material) up to the very top of the sculptures. It appears that the missing square cap from the top of the head of the woman was used as hole to pour the concrete into the inside of the sculpture. The piece of bronze which was inserted into this hole is missing and corroding iron is found in the opening (image on left). When examined with rare earth magnet iron armature was found inside of the sculpture of the woman and child. The sculptures are also attached to the stone with ferrous pins. Please note that the head of the child has the same kind of square caps, which are found on the head of the child (image on right).

1. Make a mold of the hole at the top of the head of the female figure and create a bronze insert.
2. Weld in place the insert.
3. Chase the surface of the insert and weld to blend it in with the surrounding surface texture of the bronze.
4. Remove corrosion products using laser ablation process.
5. Patinate the bronze according to the owners color specifications. Research of the original finish is needed or direction on color selection from the owner.
6. Coat the figures with hot applied mixture of microcrystalline waxes. Wax appears to be a better choice for this composition due to the fact the lower figures are very easy to climb on.
7. Apply a sacrificial cold-wax coating, and buff-out using soft cotton rags.

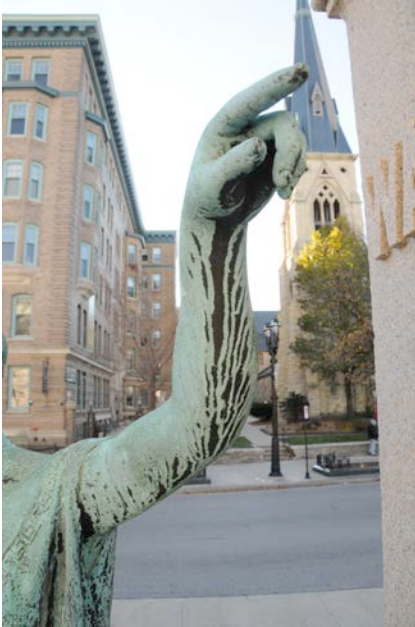
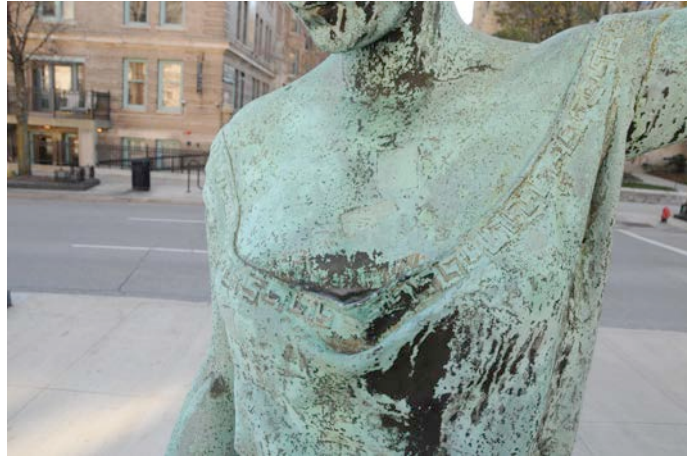
The figure of woman with a child is corroded in similar way as the sculpture of George Washington. Disfiguring streaking is found on her arms, face, and chest.
